ERDC TR-02-7

Biaxial Loading and Failure Behavior of Brick Triplets with Fiber-Reinforced Polymer Composite Upgrades

J.B. Berman, G.K. Al-Chaar, and P.K. Dutta

December 2002

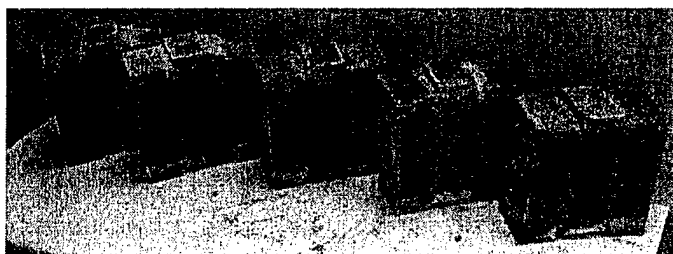
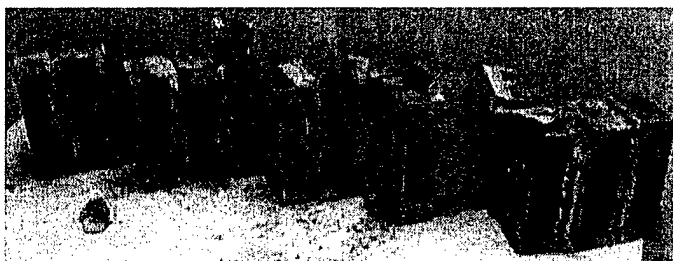
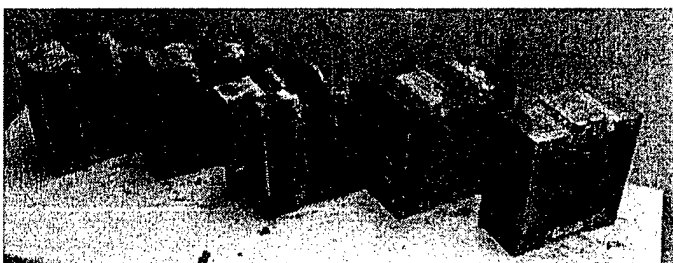
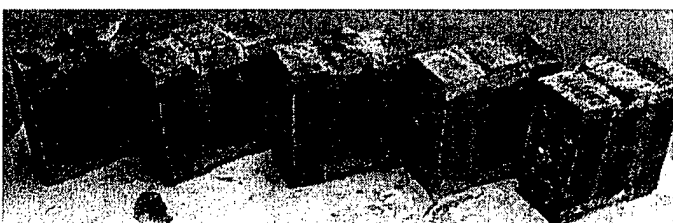
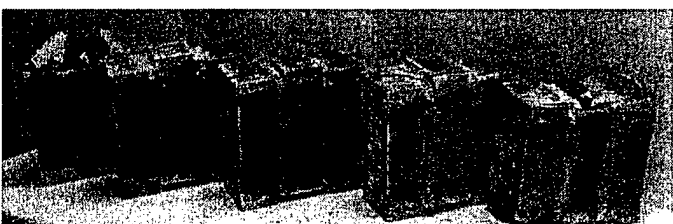
Figure 6. Modes of failure for Series I.

Group	Sample	Modes of Failure
I-0	1, 3, 4, 5	Full debond between mortar joints and FRP was observed.
	2	Debond occurred between the mortar and the FRP along one mortar joint.
	3	A tension crack in the yz-plane was resisted by the FRP.
I-12.5	All	Specimens hardly intact after testing. All FRP was torn along the mortar joints.
	2	Severe tension cracks materialized in the center brick along the xy-plane.
	3	One exterior brick exhibited a shallow crack in xz-plane.
	4	Severe tension cracks formed in the center brick in the xy-plane. Tension cracks developed in both exterior bricks in the xy- and the yz-planes.
	5	One exterior brick contained two orthogonal cracks in the xy- and xz-planes.
I-25	All	Full debond between mortar joints and FRP was observed in all samples.
	1	One exterior brick contained a tension crack in the xy-plane and separation.
	2	The center brick and one exterior brick exhibited a tension crack in the xy-plane and separation.

3	Spalling occurred at the edge of the loading end of the center brick.
	4	The area of debond between the FRP and the masonry was the largest for all samples. This indicated the center brick tended to move in the out-of-plane direction. One exterior brick exhibited cracks in the yz- and xy-planes through the top holes.
I-50	5	The exterior bricks were cracked. One brick split in yz-plane while the other split as a result of diagonal (about 45 degrees) cracking.
	All	Full debond between mortar joints and FRP occurred.
	1	A split in the center brick was observed in the xy-plane.
	2	A small amount of spalling was evident at one corner of the loading end of the center brick. Many cracks formed in the xy-plane of exterior bricks.
	3	Specimen was severely fractured as a result of tension cracks developing in the three bricks along the xy-plane.
I-75	5	The edge of the center brick at the loaded end was chipped. Many tension cracks initiated in the exterior bricks along the yz-plane.

All	Full debond between mortar joints and FRP was observed in all samples.
	1	One corner of one exterior brick was chipped. A fracture formed in the center brick on the unprotected side. A tension crack materialized on the other exterior brick in the yz-plane.
	2	The extent of debond between the FRP and the mortar joints was the largest in the set. The center brick tended to move out-of-plane away from the FRP.
	3	Both exterior bricks developed one tension crack in the xy-plane.
I-100	4	One exterior brick exhibited two tension cracks in the xy-plane.
	5	All bricks developed large tension cracks in the xy-plane.
	1	Local debond was evident along one mortar joint due to premature failure in the loading end of the center brick accompanied by a tension crack in one exterior brick in the yz-plane.
	2, 4, 5	Full debond occurred between mortar joints and FRP.
	3	Debond initiated between the mortar and the FRP along one mortar joint. A longitudinal crack also formed in the adjacent exterior brick in the xy-plane.

The failure modes of the various triplet series were captured in Figures 5 – 8 and discussed in detail in Tables 4 – 7. The resulting normal load versus shear load failure envelopes, along with their associated standard deviations, are provided for Series 0, I, and II in Figures 48, 49, and 50, respectively. One item to observe is that near the lower normal load levels, sometimes two points are plotted for a given normal load. This represents deviations in bilinear yield and ultimate failure loads. The reasoning for this difference is discussed below.

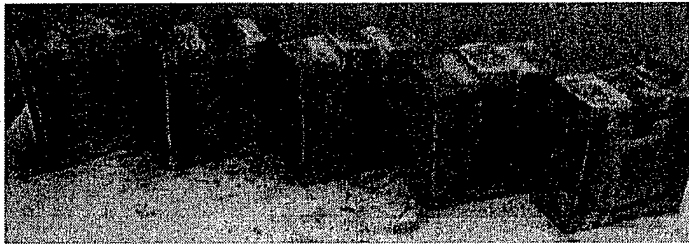
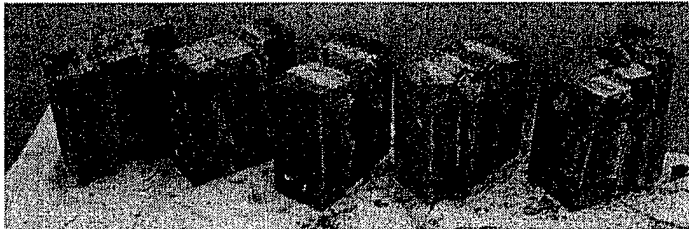
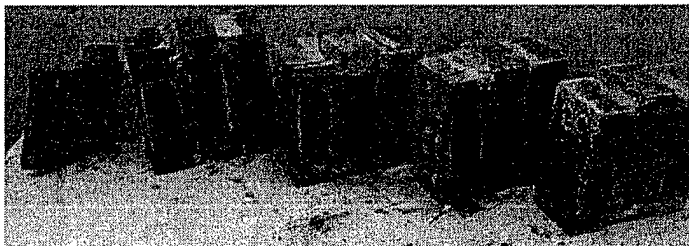
Figure 7. Modes of failure for Series II.

Group	Sample	Modes of Failure
II-0	All	Full debond between mortar joints and FRP occurred in all samples except Sample 5.
	5	The center brick totally debonded and one exterior brick contained a crack in the xy-plane.
II-12.5	1	Debond of the FRP on both sides along with spalling along the bottom of the center brick was observed.
	2, 3, 4	FRP was torn along both mortar joints.
	5	Debond between the FRP and one exterior brick occurred. Fracture of the loaded end of the central brick was observed. Orthogonal cracks developed along both xy- and yz-planes.
II-25	All	Full debond between mortar joints and FRP was observed. One or two cracks in the exterior brick formed along the yz-plane through the holes. Further cracking in the exterior bricks along the yz-direction was evident.
II-50	All	All exterior brick contained severe cracks in the xy-plane through the holes.
	1	Burst into several pieces upon failure.

II-75	All	The loading end of the center brick was chipped. Longitudinal cracks appeared in the exterior bricks along the xy-plane through the holes.
II-100	1, 2	Full debond between mortar joints and FRP was evident. Severe cracking and spalling occurred in the center brick. Tension cracks formed in the exterior bricks in xy- and xz-planes.
	3, 4, 5	Cracks developed in the xz-plane in all bricks outside the FRP surface.
